# According to custom

Seismic upgrades at San Francisco's U.S. Customs House preserve its historic character

#### U.S. Customs House Seismic Upgrade and Restoration San Francisco, Calif.

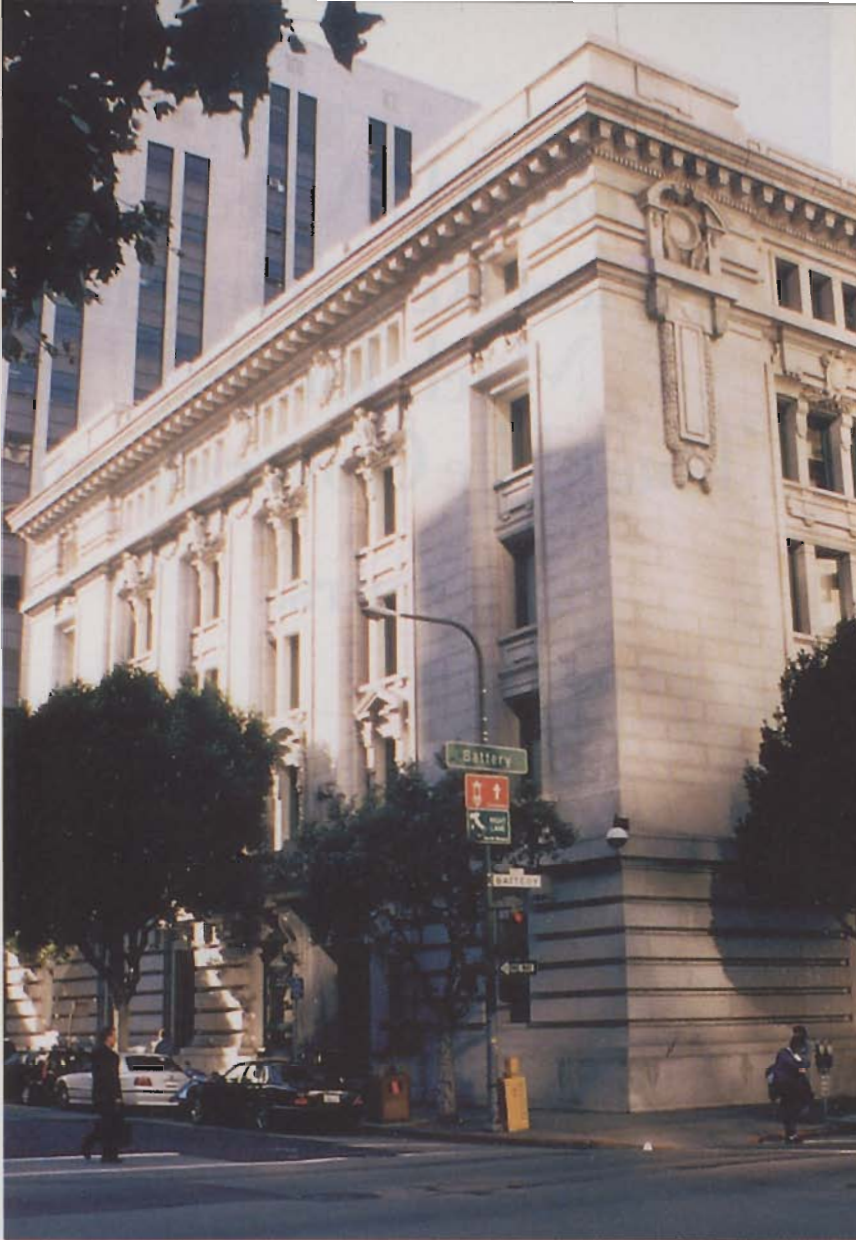
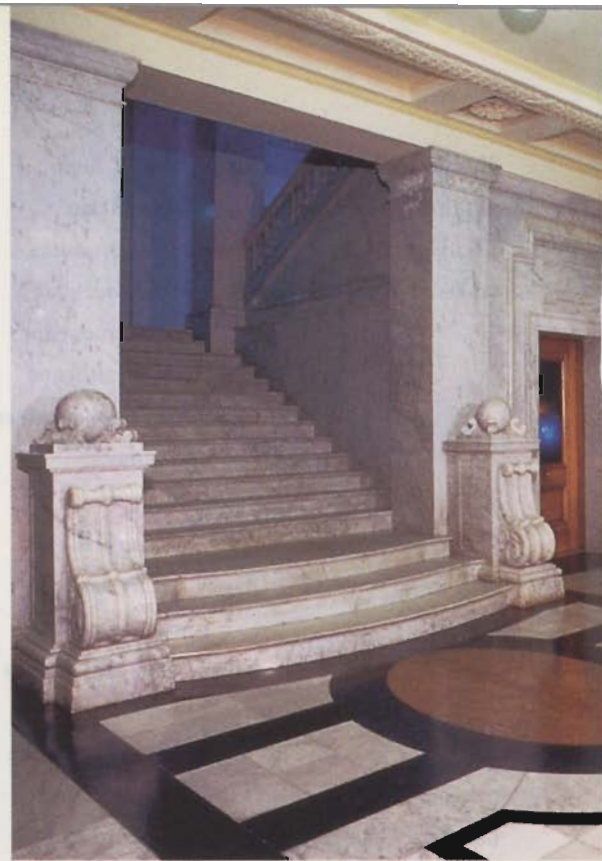
Rich in historic marble, plaster and granite finishes, the U.S. Customs House also contained its original 1906 steel structural system. Seismically upgrading this landmark involved creating new shear walls around the building's perimeter, installing new piles and adding connecting steel.

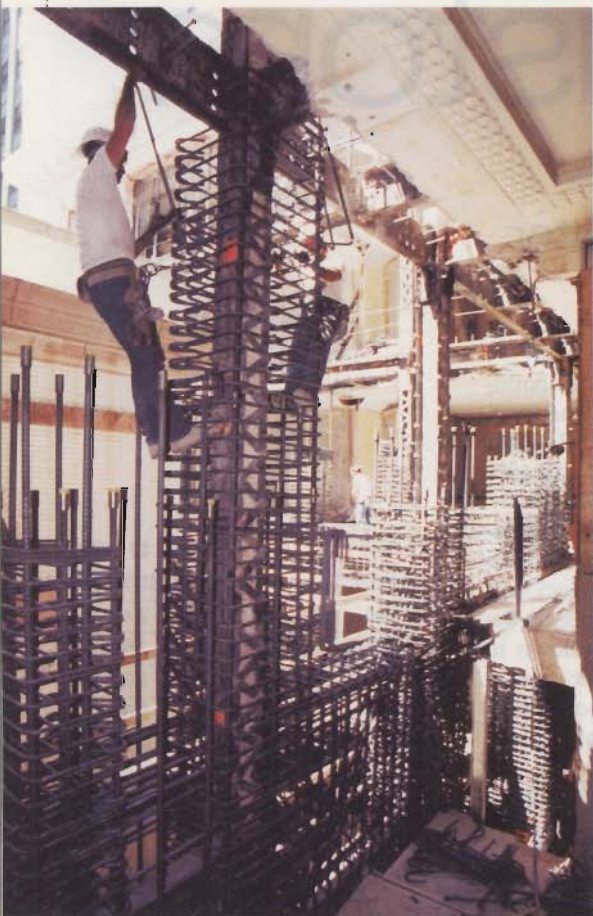
To provide lateral support, shear walls were installed around the building's perimeter. Courtyard walls (above) were completely demolished and replaced with cast-in-place concrete walls. The remaining perimeter walls (right) were demolished to their granite cladding from inside the building and replaced with shotcrete shear walls.

"The piles resist the overturning forces of the new 28-in.-thick, cast-in-place concrete shear walls that replaced the brick walls in the building's courtyard. The brick walls were removed in their entirety except for a portion under the roof," said Steven Brokken, a structural engineer with San Francisco-based URS Greiner Inc. While the shear walls were being formed, a network of temporary X-bracing was employed to shore up the courtyard area to provide protection if an earthquake occurred during construction. "Since the original steel frame was not designed to carry the load of the unsupported roof, the steel X-braces also supported the roof until the new walls were completed," said Brokken.

would not weaken the building, the plan consisted of removing the historic finishes from the interior of the three exterior walls on all five floors, demolishing 8 inches of the wall's brick infill to allow for new reinforcing steel, and cutting a 4-ft. swath in the floor around the perimeter of each wall to accommodate the thickness of the new shear walls. "At one point I could stand on the fifth floor and look down to the first — all the time knowing we had to put this all back together to look exactly the same as before," said Josehart.

Reconstructing the walls first required stainless steel dowels to be drilled from the interior and epoxied into the back side of each granite panel. The dowels were then attached to new steel reinforcing bars placed within the wall and secured to the original structural steel. According to Josehart, the dowels and steel bars were "woven" together to form a dense structural component resembling a 10-in.-thick mesh fence. Shotcrete was applied from the ground level up to form a 14-in. shear wall. "The rooms lost about 6 inches of floor space because of the thicker walls. But after the finishes were replaced the only tell-tale sign that any work had been done was that the window sills and trim are deeper," said Josehart.

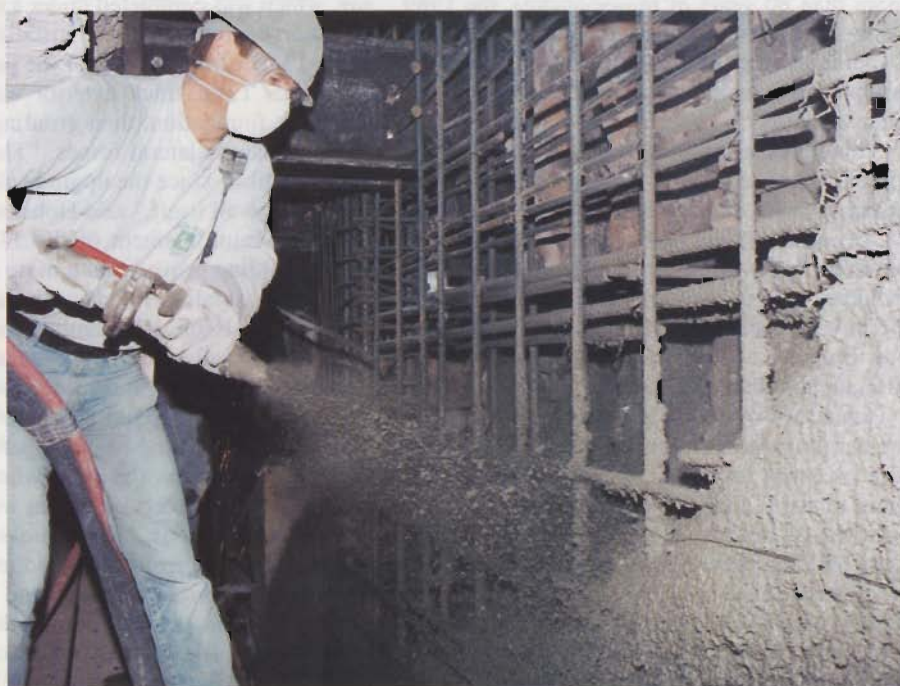
Wiring/cable channels in the new walls eliminate surface-mounted units

eter steel telecommunications channels were installed throughout the exterior walls. The channels will allow electrical and data wiring to be easily installed and removed for subsequent upgrading. "With the finishes removed, we had a novel way to install these systems without using surface-mounted units that would detract from the historic nature of the building," said Mel Schenck, director and project architect with KMD.

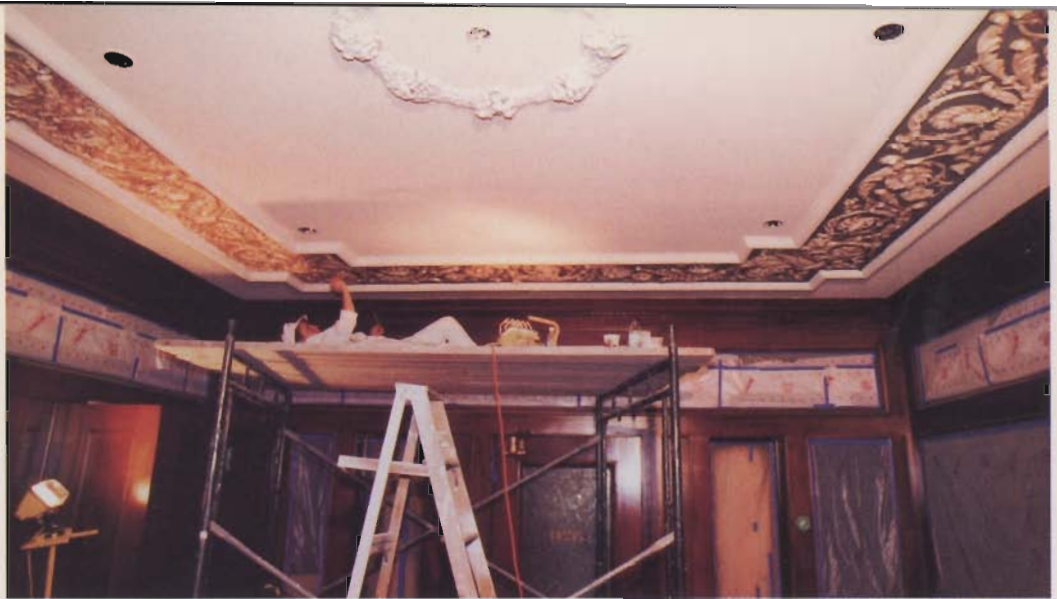
The historic finishes in the director's office include floor-to-ceiling wood and leather paneling and gilded ceiling plaster that were restored to their original specifications.

One area where measurements could not be altered was on the third floor in the historic director's suite. The corner office's finishes, which included floor-to-ceiling wood and leather paneling, needed to be restored to their exact dimensions. Hence, the shear wall assembly was reduced to 6 inches in this area before being spread out to the full 14 inches on the adjoining floors.
